# **PART III**

# PORT OF NEWCASTLE HERITAGE REGISTER

Item Name: Navigational Markers of Rear Main Lead Tower

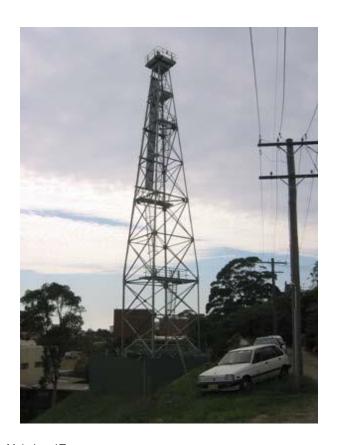
Physical Condition: Good

**Caption:** Rear Main Lead Tower **Copyright:** EJE Architecture

Asset Management Plan requires condition-based assessments to be undertaken every two years.

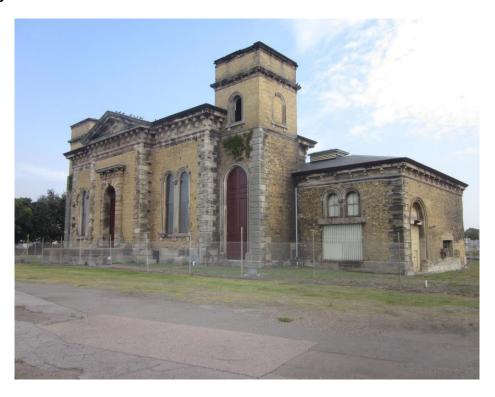
**Caption:** Facade and eastern boiler wing. This wing matches but post-dates the main engine room.

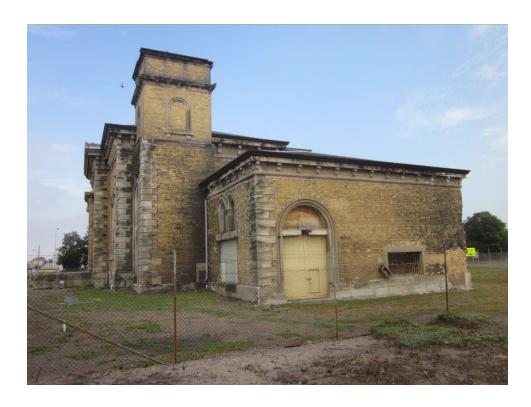
Caption: Eastern facade; unsympathetic awning formerly located above door has been removed.

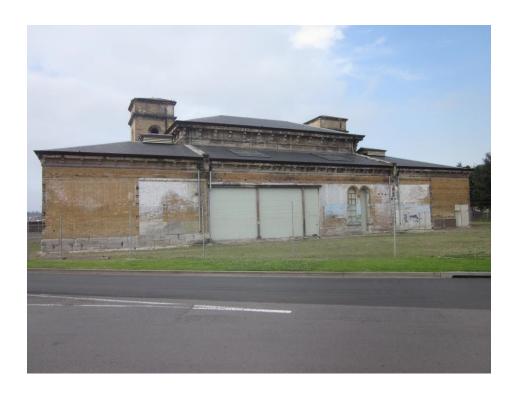
**Caption:** North-eastern facade. Note effects of removal of intrusive additions on this elevation.

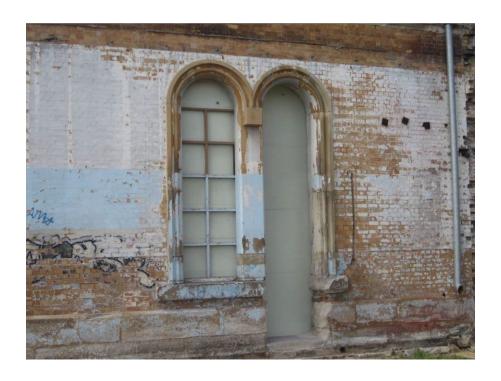
**Caption:** Window adapted to provide access to now-demolished unsympathetic additions.

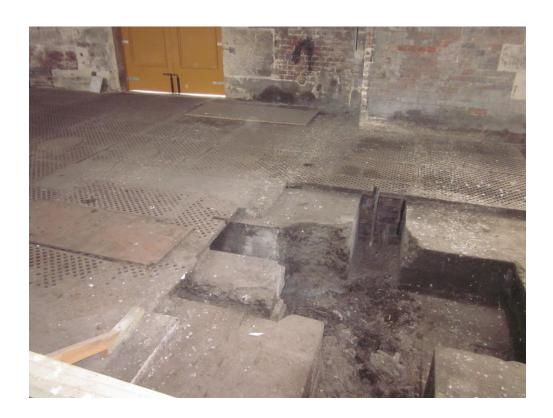
Caption: Void from removed engine, showing iron or steel flooring.

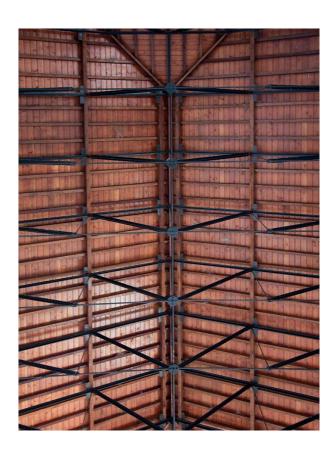
Physical Condition: Poor to fair. Now secured against vandalism. Pigeons entering via window of eastern accumulator tower, near

Caption: Engine House Roof

**Management:** water proofing; preservation of significant fabric, particularly the sandstone; and *repairing of the roof breach*.

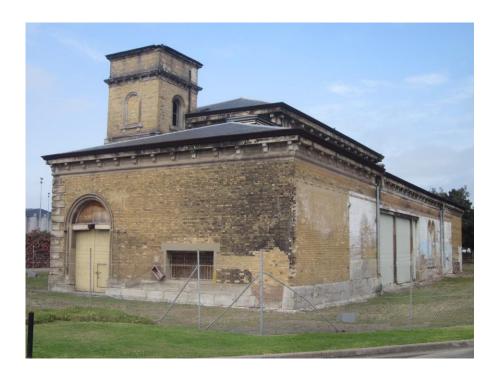
Caption: Eastern elevation; former chimney aperture was originally arched. Pigeons enter through broken tower window.

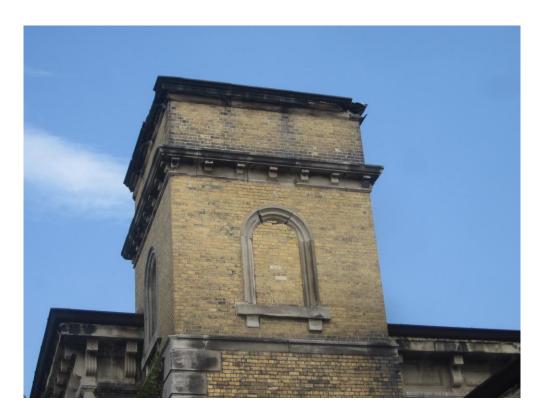
Caption: Eastern accumulator tower

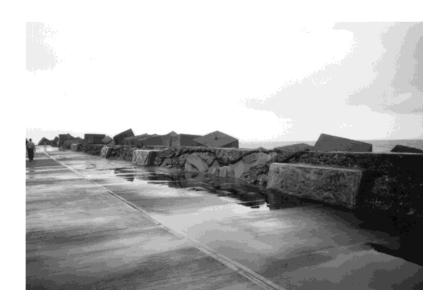
Caption: Detail of the eastern end of southern breakwater, showing mass concrete block wall

construction and bas-relief sculptures.

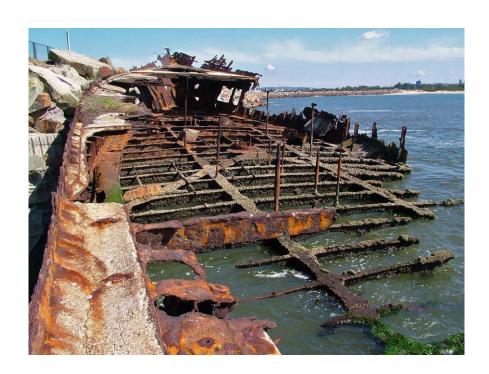
Physical Condition: Ruinous.

**Modification Dates:** Stern section blown off; masts cut down; gradual, accelerating deterioration.

**Caption:** *Adolphe* wreck, looking for ard; little now remains of the upper deck. Note structural members of lower deck. Portions of hull may remain below water.

Recommended Management: Follow State Agency Heritage Guide; allow to continue to deteriorate through natural processes.

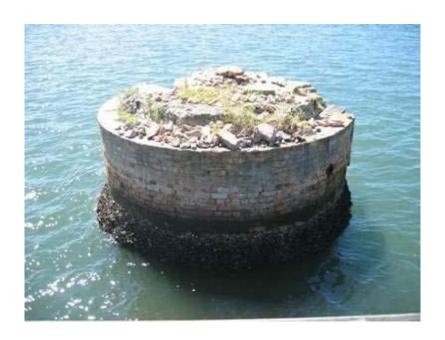
Physical Condition: Fair to poor. Mortar deteriorated and missing in places. Brickwork missing in places.

Caption: Crane Base No.15
Copyright: EJE Architecture
Image by: Shea Hedley
Image Date: 16/02/2007
Image Number:

**Recommended**The Capital Dredging Project Approval provides for the demolition of the item to make way for the Dyke

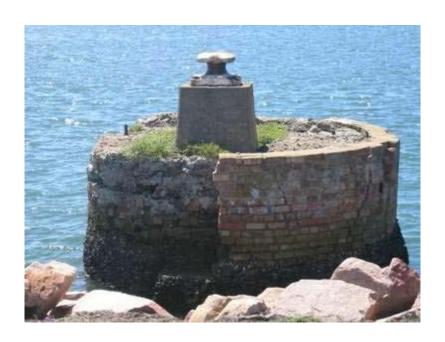
**Physical Condition:** Fair to poor. Mortar deteriorated and missing in places; brickwork missing in places.

Caption: Crane Base No.14
Copyright: EJE Architecture
Image by: Shea Hedley
Image Date: 16/02/2007
Image Number:

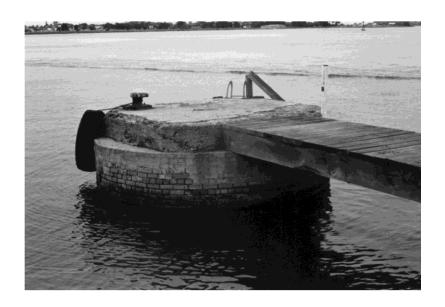
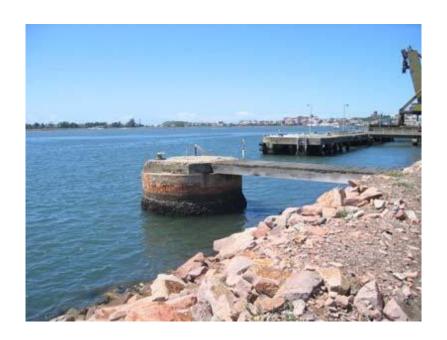
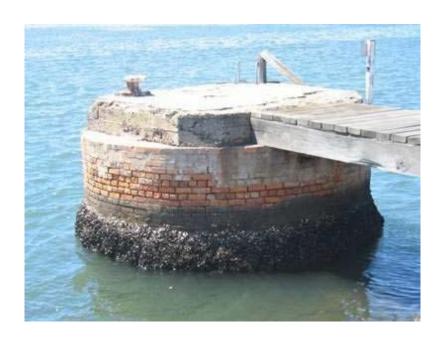
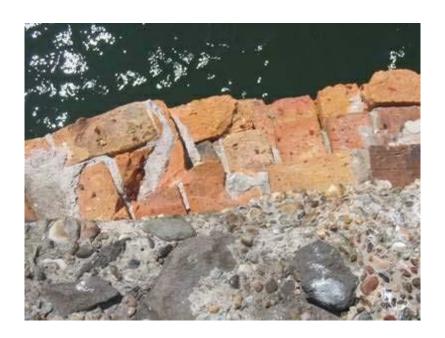
Physical Fair to poor. Mortar deteriorated and missing in places. Brickwork missing in places. Steel

**Condition:** ladder is rusting in places.

**Caption:** Crane Base No.13. **Copyright:** Suters Architects

Management: Maintain as part of group. Repair brickwork with lime mortar (not cement). Replace ladder when

necessary. Maitain and/or replace timber walkway.

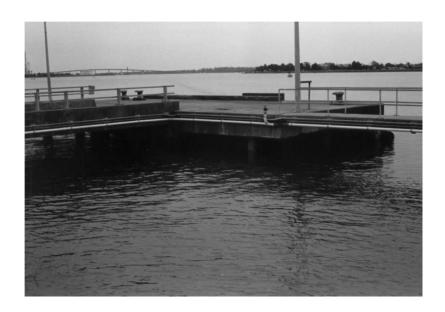
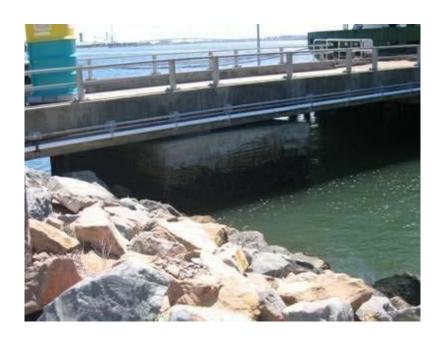
**Physical Condition:** Appears good. Largely obscured by dolphin.

Caption: Concrete 'dolphin' under which is located Crane Base No.10

**Management:** Follow Conservation Management Plan 2005. Repair with **lime mortar** (*not* cement) as necessary.

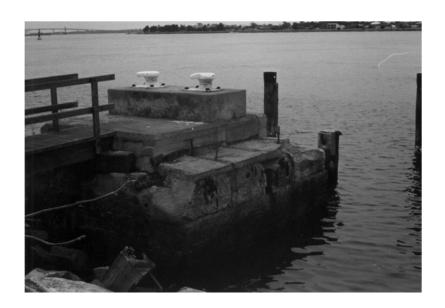
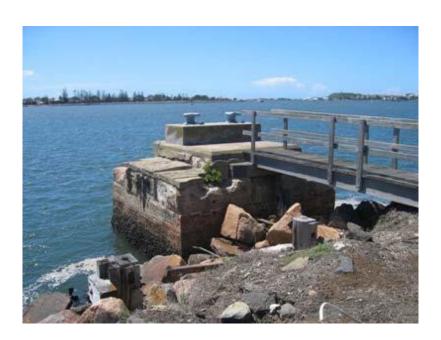
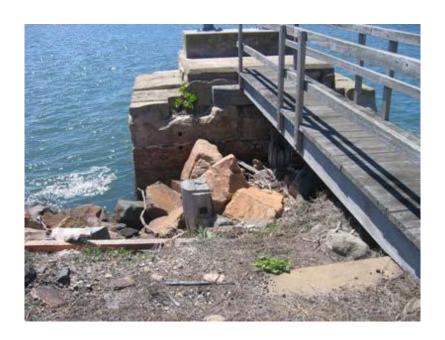
Physical Condition: Fair. Some brickwork deteriorated.

**Caption:** Crane Base No.8 **Copyright:** Suters Architects

Recommended Maintain as part of group. Replace timber access bridge when necessary. Conserve remnants of

**Management:** timber dolphin. Repair brickwork where necessary.

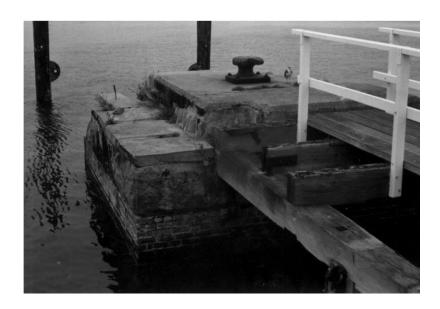
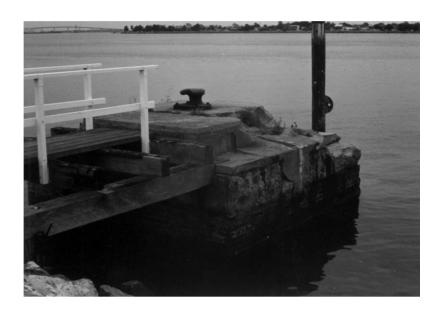
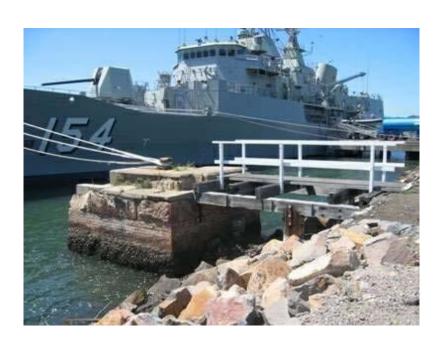
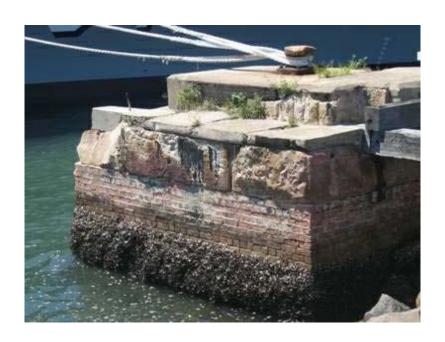
Physical Condition: Fair.

Caption: Crane Base No.7

**Management:** Maintain as part of group. Replace newer timber access bridge when necessary . Conserve timber

access. Repair brickwork with lime mortar; repair with sandstone where necessary. Maintain timber

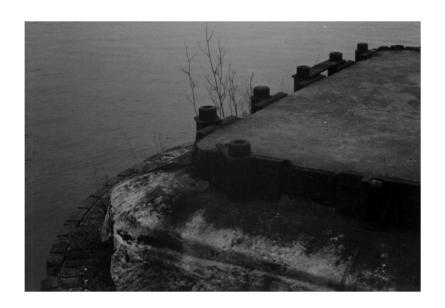
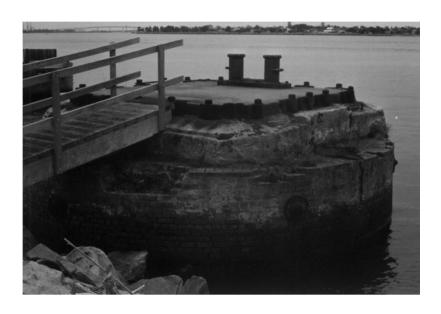
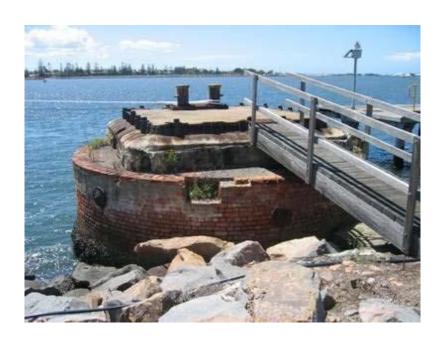
Physical Condition: Fair to poor. Severe mortar deterioration. Bricks missing.

**Caption:** Crane Base No.6 **Copyright:** Suters Architects

**Recommended** Maintain as part of group. Repair with **lime mortar** as necessary. Replace access bridge when

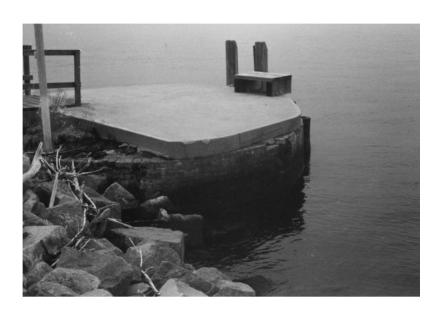
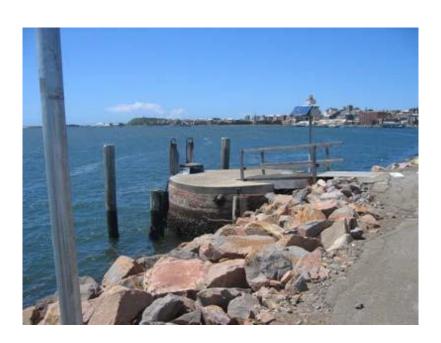
Physical Condition: Fair. Brickwork deteriorating in places.

**Caption:** Crane Base No.5 **Copyright:** Suters Architects

**Recommended** Maintain as part of group. Repair brickwork as necessary with lime mortar. Replace concrete slab,

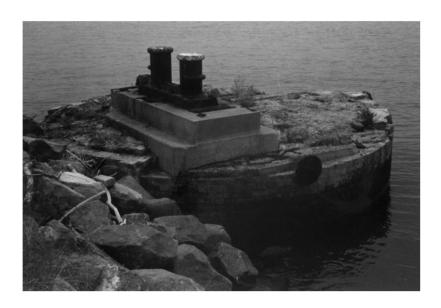
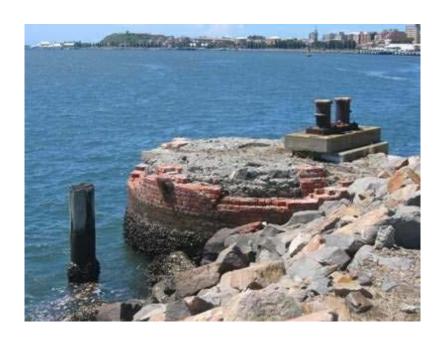
Physical Condition: Variable. Brickwork unstable in places.

Caption: Crane Base No.4
Copyright: Suters Architects
Image by: Linda Smith

**Management:** Maintain as part of group. Repair brickwork with lime mortar (not cement) as necessary.

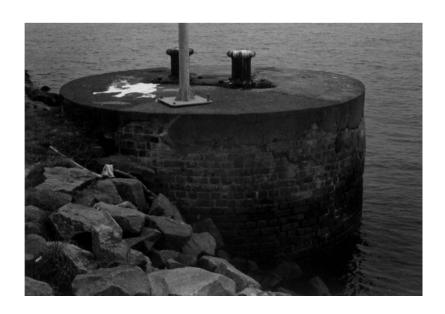
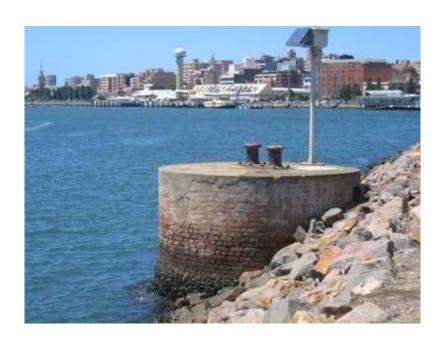
Crane Base No.3 Item Name: Carrington [Newcastle City] Location: SHI Number 3930028 **Physical Condition:** Fair to good. Brickwork deteriorated, particularly at water level. Modification Dates: Crane removed in 1908. Recommended Management: Maintain as part of group. Repair brickwork as necessary. Produce a Conservation Management Plan (CMP). Management: **Further Comments:** The crane base is a significant record as a remnant of the early steam cranes that were Criterion (a) moved from Queen's Wharf to the Dyke in 1889. Criterion (b) Criterion (c) Criterion (d) Criterion (e) Criterion (f) Criterion (g) All though not intact the location and process by which coal was loaded can be demonstrated by this item. Integrity / Intactness: Fair References: Studies: **Author** Title Number Year **Suters Architects** s170 Heritage & Conservation Register 2001 Parcels: Latitude: Longitude: Location validity: Spatial Accuracy: Map Name: Map Scale: AMG Zone: Easting: Northing: Listings: Name: State Environmental Planning Policy Title: Bullock Island Crane Bases Number: Date: 2011 (Three Ports) 2013 **Custom Field One: Custom Field Two: Custom Field Three:**

**Caption:** Crane Base No.3 **Copyright:** Suters Architects

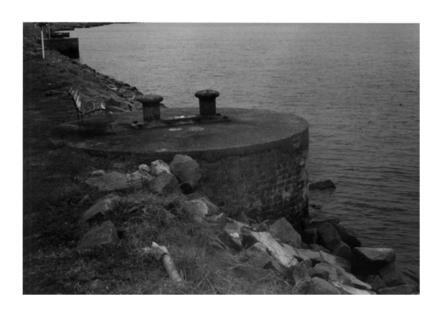
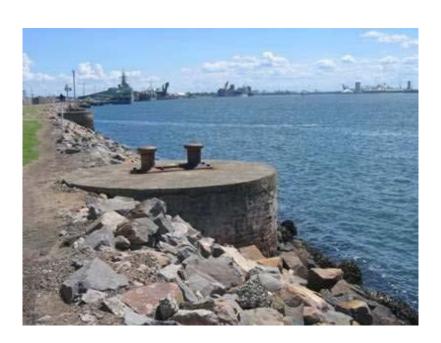
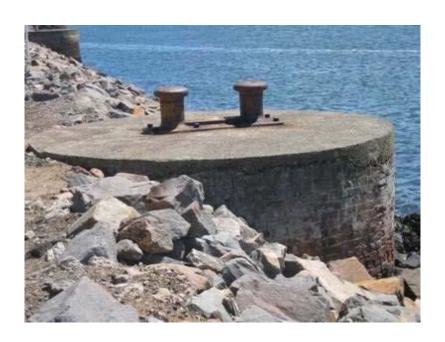
> Physical Condition: Appears good. Brickwork at water's edge not inspected: may be deteriorating. Modification Dates: Crane removed in 1908. Extend Conservation Management Plan to include all crane bases and Hydraulic Power House. Recommended Management: Maintain as part of group. Repair brickwork as necessary. Produce a Conservation Management Plan (CMP). Management: **Further Comments:** The crane base is a significant record as a remnant of the early steam cranes that were Criterion (a) moved from Queen's Wharf to the Dyke in 1889. Criterion (b) Criterion (c) Criterion (d) Criterion (e) Criterion (f) Criterion (g) All though not intact the location and process by which coal was loaded can be demonstrated by this item. Integrity / Intactness: Good References: Studies: **Author** Title **Number Year Suters Architects** s170 Heritage & Conservation Register 2001 Parcels: Latitude: Longitude: **Location validity: Spatial Accuracy:** Map Name: Map Scale: AMG Zone: Easting: Northing: Title: Bullock Island Crane Bases Number: Date: 2011 Listings: Name: State Environmental Planning Policy (Three Ports) 2013 **Custom Field One: Custom Field Two: Custom Field Three: Custom Field Four:**

**Caption:** Crane Base No.2 **Copyright:** Suters Architects

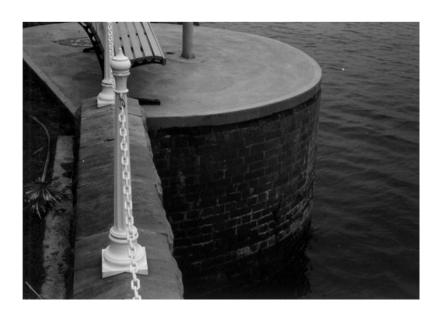
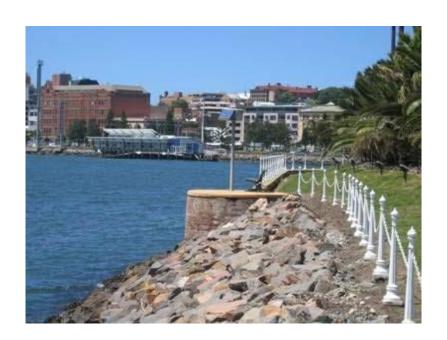
Crane Base No.1 Item Name: Carrington [Newcastle City] Location: SHI Number 3930030 Physical Condition: Appears good. Modification Dates: Crane removed in 1908. Recommended Maintain as part of group. Repair brickwork as necessary with limemortar. Management: Management: Follow State Agency Heritage Guide. **Further Comments:** Criterion (a) The crane base is a significant record as a remnant of the early steam cranes that were moved from Queen's Wharf to the Dyke in 1889. Criterion (b) Criterion (c) Criterion (d) Criterion (e) Criterion (f) Criterion (g) All though not intact the location and process by which coal was loaded can be demonstrated by this item. Integrity / Intactness: Good References: Studies: Author Title Number Year s170 Heritage & Conservation Register **Suters Architects** 2001 Parcels: Latitude: Longitude: Location validity: **Spatial Accuracy:** Map Name: Map Scale: AMG Zone: Easting: Northing: Listings: Name: State Environmental Planning Policy Title: Bullock Island Crane Bases Number: Date: 2011 (Three Ports) 2013 **Custom Field One: Custom Field Two:**

Caption: Crane Base No.1

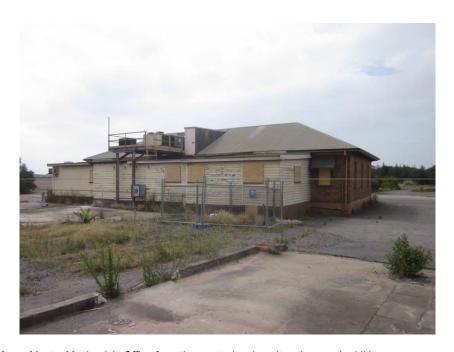
Physical Condition: Fair; deteriorating with proximity to salt water, and through lack of occupancy.

Caption: Master Mechanic's Office from the west, showing alterations and additions

Master Mechanic's Office Item Name: Selwyn Street, Mayfield North [Newcastle City] Location: SHI Number Not yet allocated Recommended Approval has been given for the demolition of this item to make way for new portinfrastructure. Management: Management: Follow State Agency Heritage Guide with regard to demolition. **Further** Comments: Historically important as evidence of the day-to-day operation and maintenance of steelmaking plant. Criterion (a) Criterion (b) Criterion (c) Criterion (d) Criterion (e) Criterion (f) Representative of hierarchical management structures of the pre-War period, exhibiting the esteem in which Criterion (g) highly-skilled engineers responsible for the physical operation and maintenance of the plant were held. Integrity / Fair Intactness: Author Title References: Year Studies: EJE Group/Peter Fenwick BHP Steelworks CMP 1991 Parcels: Latitude: Longitude: Location validity: **Spatial Accuracy:** Map Name: Map Scale: AMG Zone: Easting: Northing: Listings: State Environmental Planning Policy (Three Ports) 2013 **Custom Field One: Custom Field Two: Custom Field Three: Custom Field Four: Custom Field Five: Custom Field Six:**

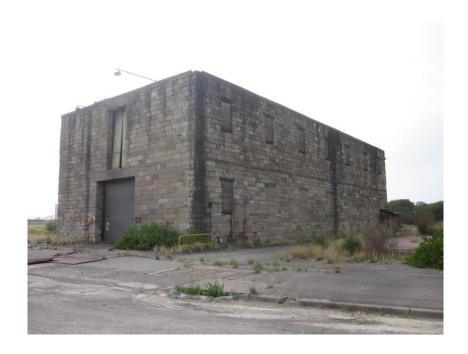
Physical Condition: Poor.

**Caption:** Former BHP Pattern Store, from the south-west; note stone construction and flat concrete roof.

**Recommended** Approval has been given for the demolition of this item to make way for new port infrastructure; re-use
