# **Mayfield Concept Plan Approval**

## **Quarterly Stormwater Monitoring Report**

September 2022 to November 2022 Date of sampling: NA Date Published: 31/1/2023

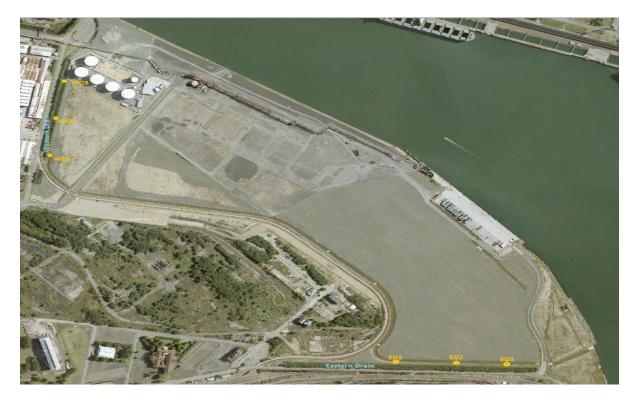
## Figure 1: Mayfield Site Water Quality Monitoring Locations

To support the strategy PON conducts an ongoing site wide monitoring program to confirm that the site continues to meet the commitments and requirements of the Concept Plan Approval. Sampling is undertaken on a quarterly basis at the downstream extent of the site drainage infrastructure prior to discharge into the Eastern and Western drains. There are a total of six sampling locations. Please refer to Figure 1 below.
